July 2003

Socio-Economic Series 03-010

EVALUATION OF OPTIMAL BATH GRAB BAR PLACEMENT FOR SENIORS

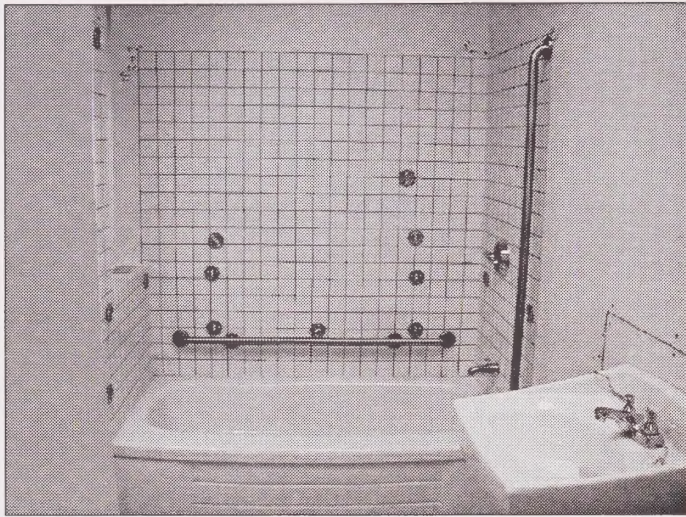
Figure 1: Canadian Standards Association (CSA) configuration

The CSA configuration is one horizontal grab bar, 120 cm long, and one vertical grab bar, 120 cm long. Both grab bars are 18 cm above the rim of the tub. The horizontal bar is on the back wall of the tub. The vertical grab bar is on the same wall as the tub faucet.

The last two configurations ranked significantly lower than the others. The OBC was the only configuration that lacked a second bar on the entry wall. Also, the L-shaped bar was relatively ineffective in helping participants get in and out of the tub. The reasons for the low ranking of the CSA configuration are not fully understood as yet but may have to do with the excessively low positioning of the back wall bar.

2. For sitting down: there were no significant differences for the five configurations, although the CSA configuration was most used (87.3 per cent). Given the All Bars option, most participants used the angled or horizontal bar on the back wall for assistance (43.1 and 31.4 per cent, respectively).

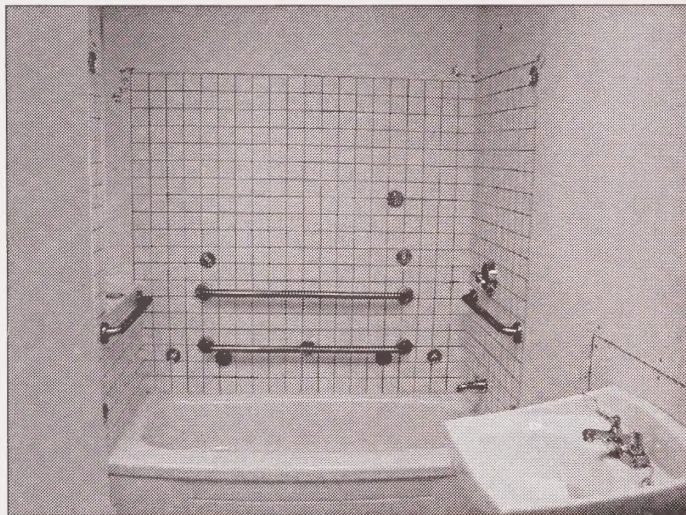
Figure 2: U.S. Uniform Accessibility Standards (UFAS) configuration

The UFAS configuration is four horizontal grab bars. Two are mounted on the back wall; the third is mounted on the faucet wall; the fourth, on the wall opposite the faucet wall. Each back wall grab bar is 82 cm long.

The lower back wall grab bar is 23 cm above the rim of the tub. The upper is 48 cm above the rim of the tub. The bars on the faucet wall and the wall opposite the faucet wall are each 61 cm long and mounted 48 cm above the rim of the tub.

3. For standing up: there were no significant differences for the five configurations, although the UFAS was most used (86.3 per cent). Given the All Bars option, most participants used the angled or horizontal bar on the back wall (54.9 and 21.6 per cent, respectively).

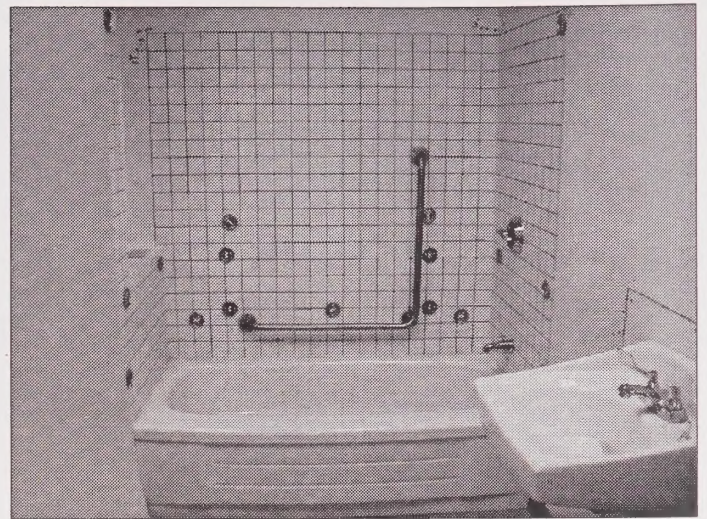
Figure 3: Ontario Building Code (OBC) modified configuration

The OBC modified configuration is an "L"-shaped bar mounted on the back wall. Each side of the "L" is 75 cm long. The leg parallel to the rim of the tub is 17 cm above the rim. The vertical bar, at a 90-degree angle to the bottom of the "L," is 38 cm from the faucet wall.

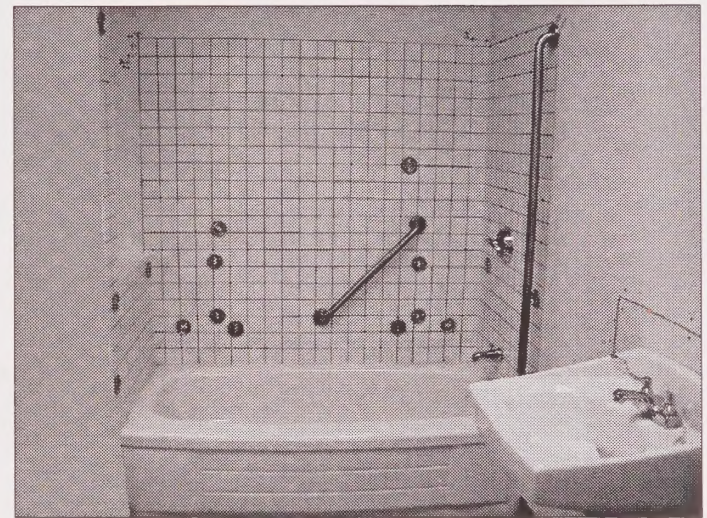
Figure 4: Ottawa-Carleton Common (OCC) configuration

The OCC configuration is two bars. The bar on the back wall is 60 cm long. It is mounted at a 45-degree angle, with the lowest point 23 cm above the rim of the tub, 74 cm from the faucet wall. The highest point of the bar is 30 cm from the faucet wall. The second grab bar is on the faucet wall. It is vertical, 120 cm long, and 18 cm above the rim of the bathtub.

1. For getting into the bathtub: most used the OCC configuration (68.8 per cent); the OBC was used least (45.1 per cent). When given the option of All Bars, people used the vertical bar on the faucet wall most, followed by the angled bar on the back wall (32.3 and 20.6 per cent, respectively).

4. Getting out of the bathtub: the OCC was the configuration most used (62.7 per cent). The OBC was least-used (30.4 per cent). Given the All Bars option, most participants used the vertical bar on the faucet wall or the angled bar on the back wall (32.3 and 16.7 per cent, respectively).

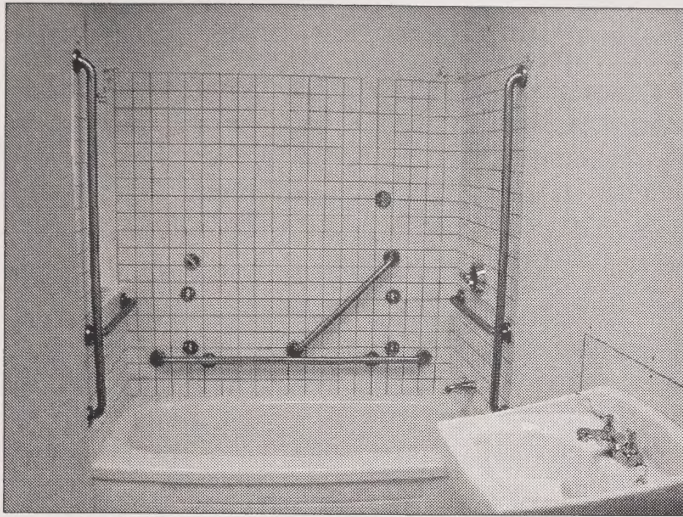
Figure 5: All Bars configuration

The All Bars configuration is a composite of the CSA, UFAS, OBC modified and OCC configurations.

Rank # 1 All Bars;

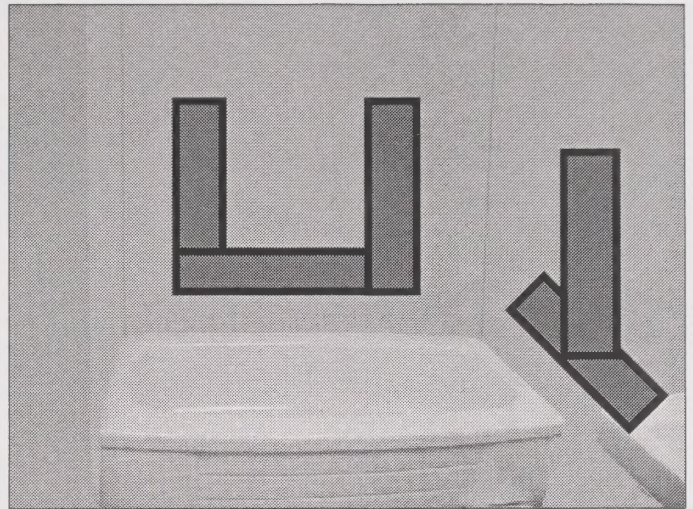
Figure 6: The dark blocks indicate the “U-shaped” and “Inverted T-shaped” wall areas requiring reinforcement for grab bar installation.

4. Non-slip surfaces on edges (bathtub rims, front and back) should be incorporated as safety features in bathtubs used by seniors.
5. In new bathtub constructions, a “U-shaped” drywall reinforcement in the back wall, along with an “L- or inverted T-shaped” drywall reinforcement area in each the faucet and head wall, should be incorporated to facilitate the installation of secure and appropriate grab bars.
